Basement Repair Update

Synopsis of Scope of Work

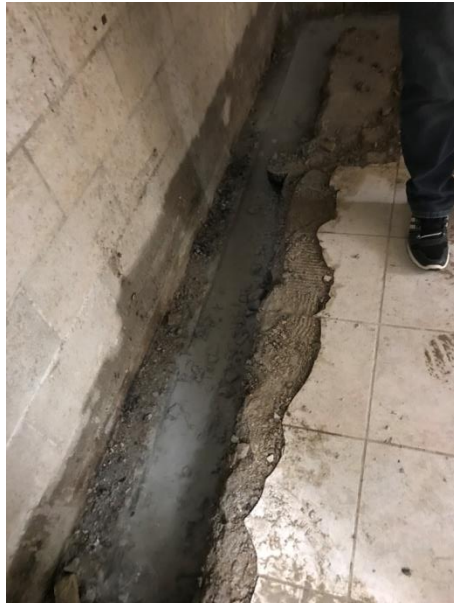
Once wall studding was removed the first step was breaking of the concrete floor where it meets the foundation. This revealed the anticipated problem of groundwater at the foundation. As most will note this is floor in the ladies washroom.
